# Rotorgraph

## Roof Inspection Report

124 Livingstone Road

16<sup>th</sup> February 2025

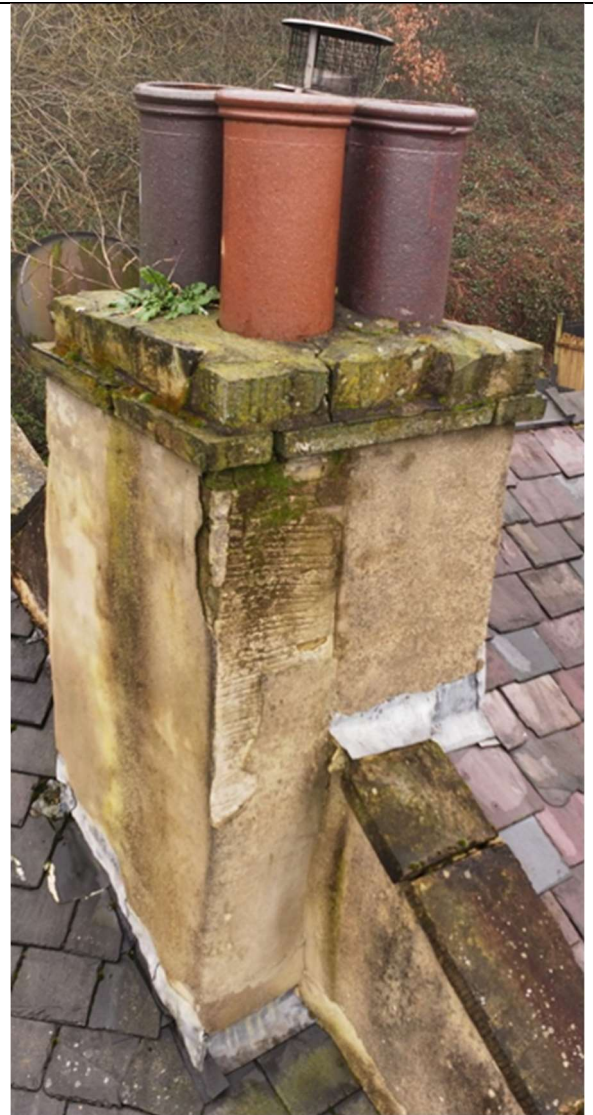
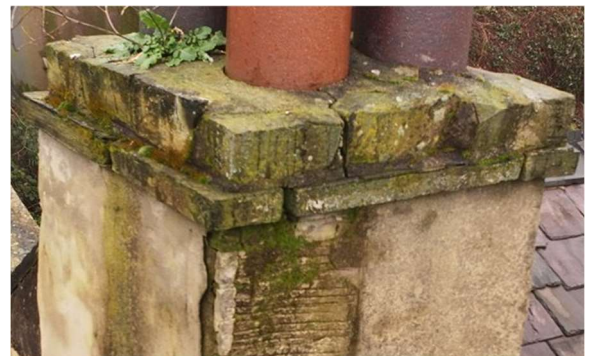
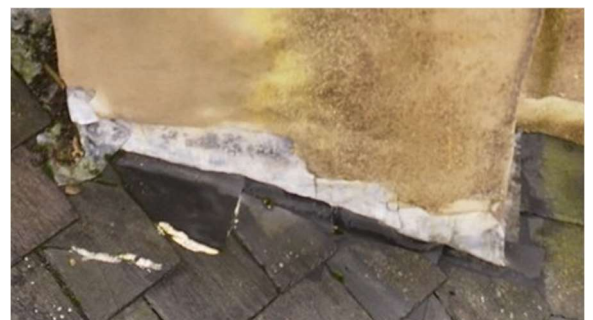
Based on their colour, these look to be the original flashings. The detailing is incorrect and where the flashing is detailed into the stack, the mortar bed has been rendered over

which means that the render will get damaged when the flashings need to be replaced.

You should budget to replace the flashings when the render is replaced.

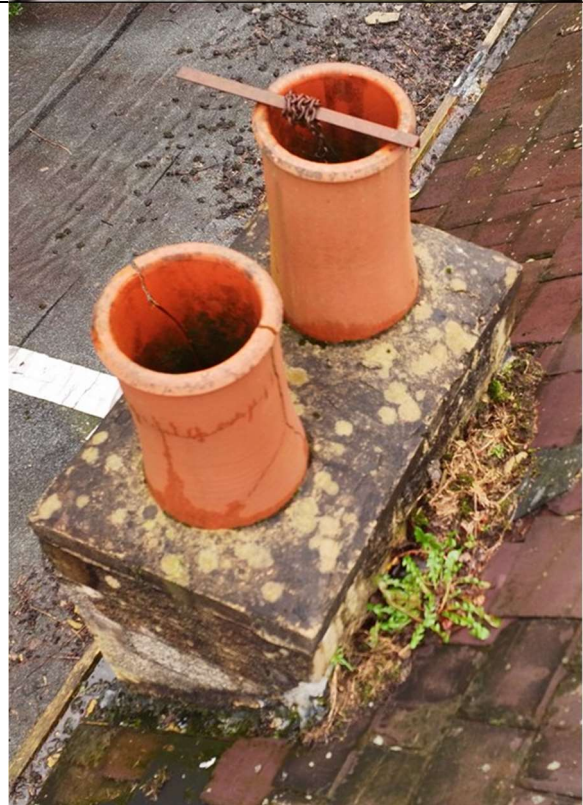
There are two clay chimney pots, left and right. The left-hand pot is cracked and should be strapped or replaced this year. The right-hand pot has a metal bar and chain over the top going down the flue – we are not sure what this is for and you should try to ascertain this. Whatever problem this is trying to address, this is unlikely to be the correct way of doing it.

Both of the pots are open. If the flues are redundant, they should have an appropriate vented cap fitted to the top of the pot. If the flues are in use, they should have the appropriate cowl (based on the appliance) fitted to the top of the pots.

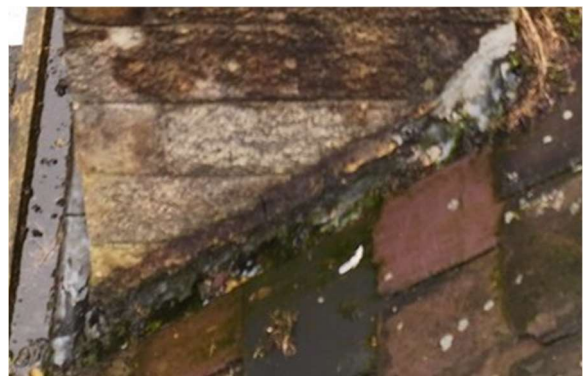
There is no corbelling which will likely result in additional moisture stress being placed on the stack.

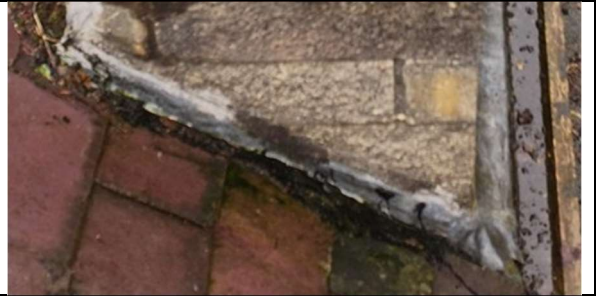
The stack appeared to be in acceptable condition. There is a lot of debris collecting around the back of the stack, this should be cleared in the next couple of months and the area under the debris checked for any further defects.

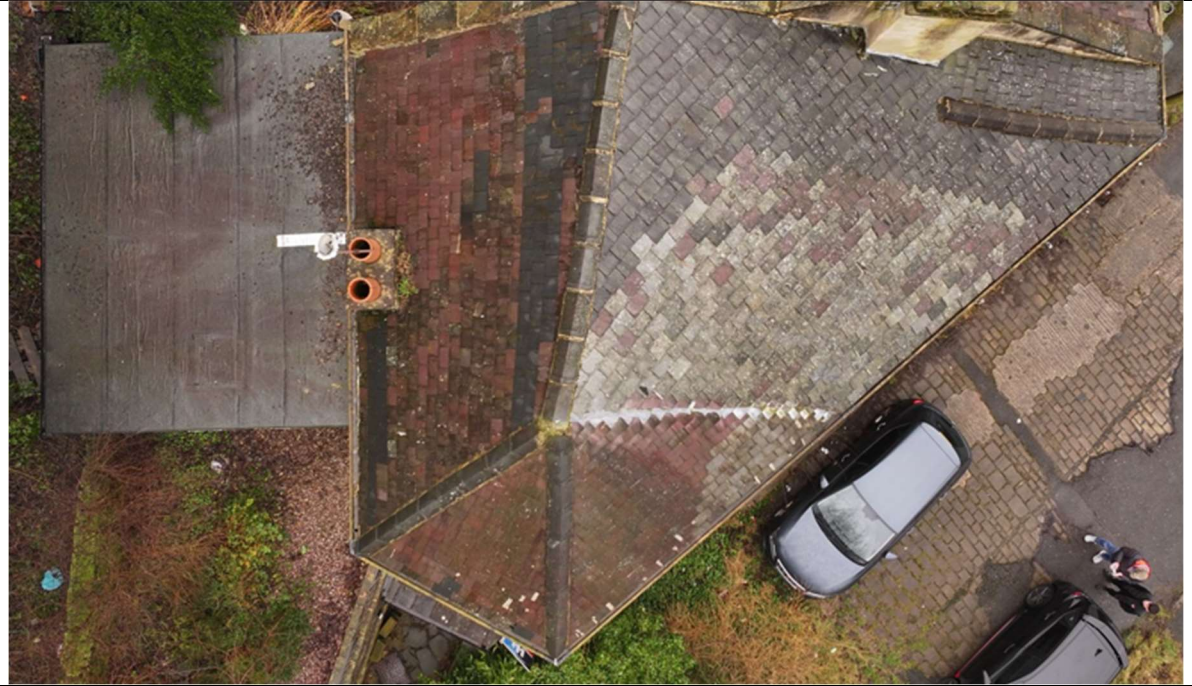
The flashing appears to be missing around the left-hand side of the stack. The flashing

details that are present appear to be incorrect. We recommend you plan to replace the flashing in the next couple of years.

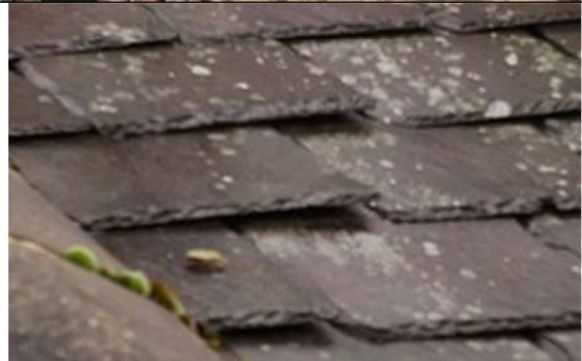
Side-on photo of the front pitch. The pitch has 3 asymmetric sections, left-hand section, centre section and right-hand section. Generally speaking, the pitch is in poor condition with immediate repairs required and consideration to be given to recovering the roof in the not-too-distant future.

The shape of the roof is unusual and is likely going to be more expensive to repair because of this.

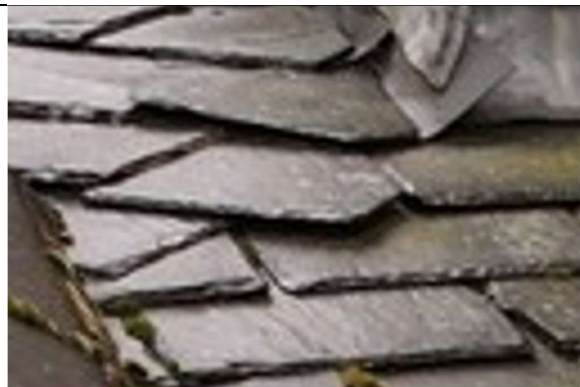
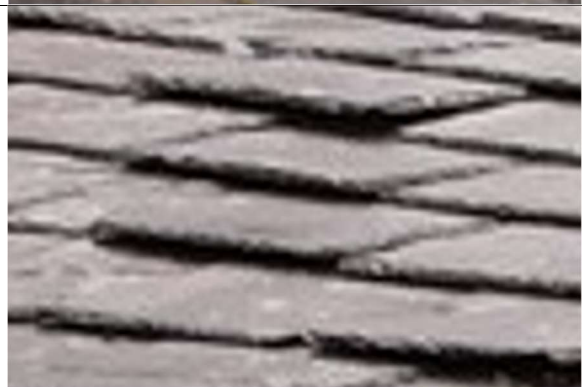
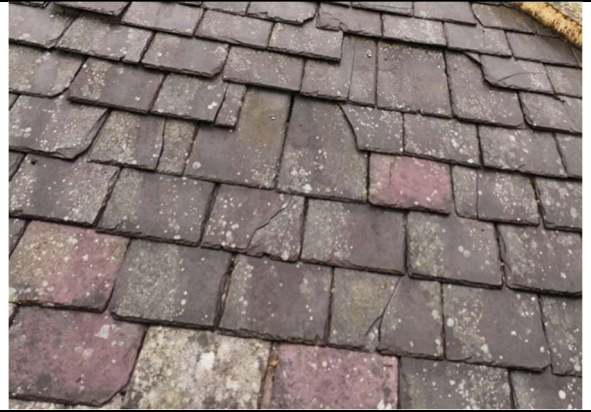
General comment – in several areas, the slates do not sit flat to the pitch which will likely accelerate fixing failure as a result of wind rattle.

We have included some example photos of this as opposed to every area where this is a problem.

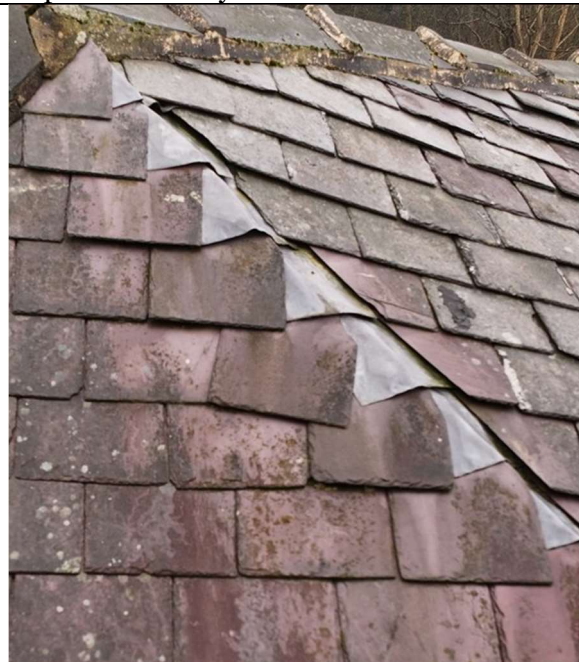
The area of missing and damaged slates near the apex of the pitch should be replaced as soon as possible.

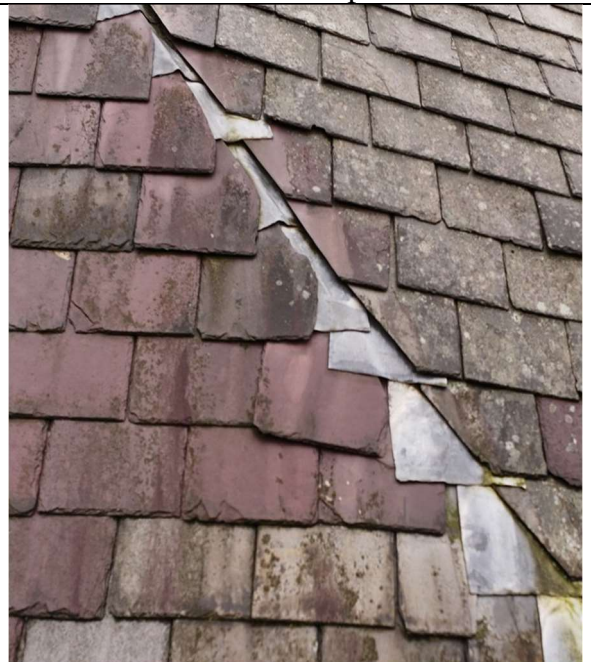
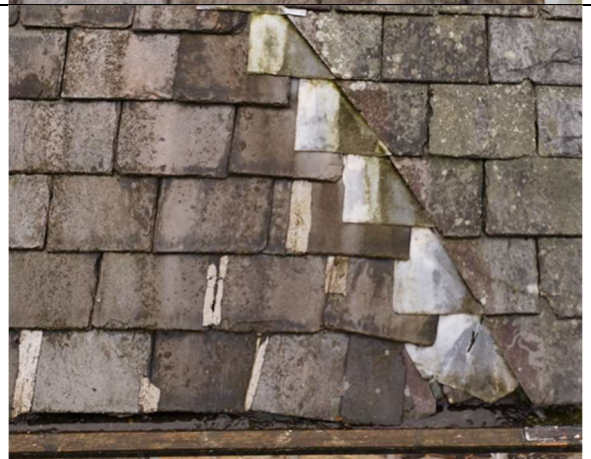
We recommend all of the slates and lead be checked along this abutment as it appears to be in poor condition with lead and slates slipping.

Repairs are likely to be needed and should be undertaken in the next couple of months.

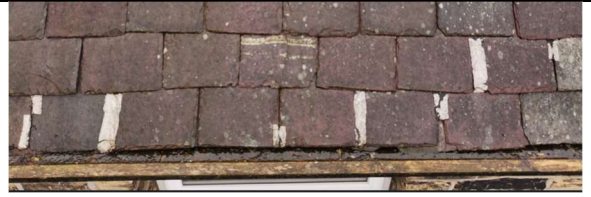
Left-hand to centre section abutment - the condition of the covering and detail is particularly poor in this area and we recommend repairs are undertaken in the next couple of months.

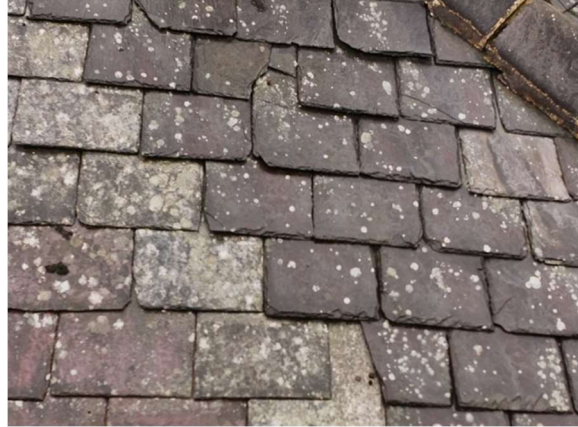
Areas of slates across the eaves course have been stuck on with a Flashband-type product. This kind of repair is inappropriate and the damaged slates should be replaced appropriately replaced and re-affixed in the next couple of months.

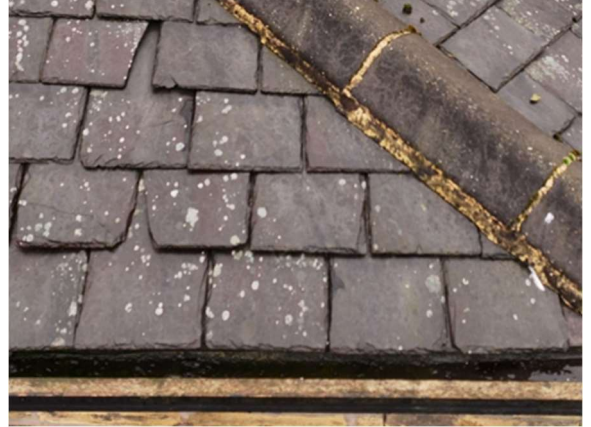
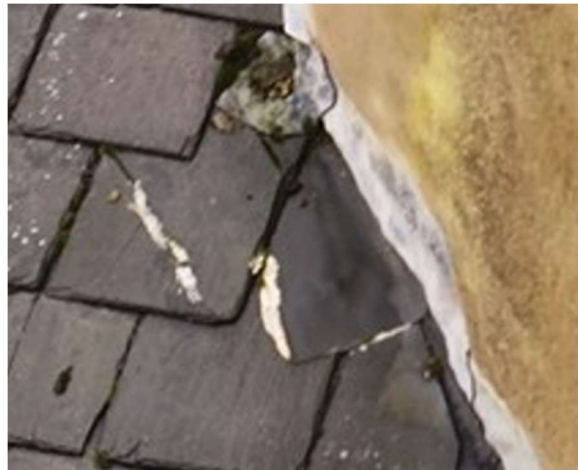
Centre section – damaged slates should be replaced this year – example photos below.

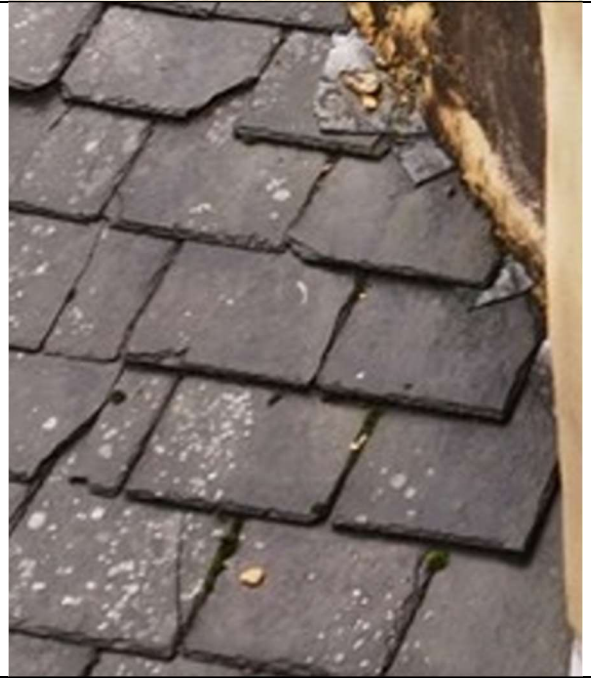
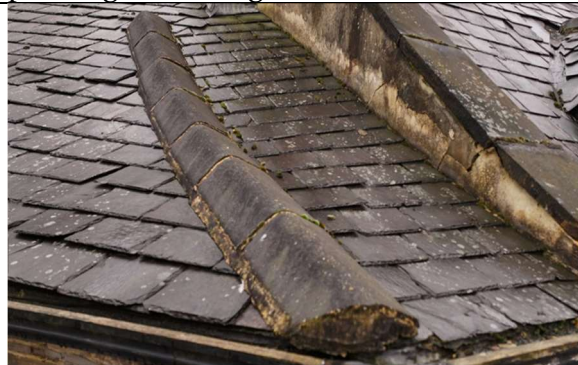
The damaged tiles around the chimney stack should be replaced this year.

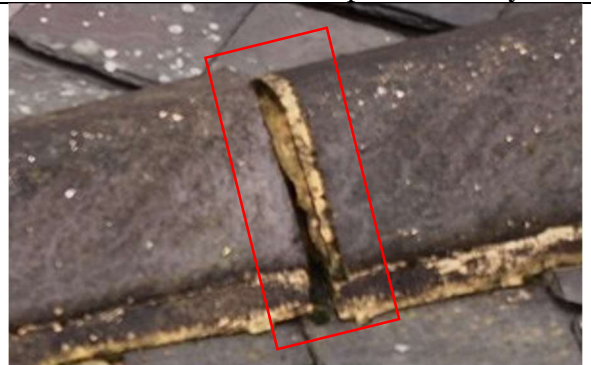
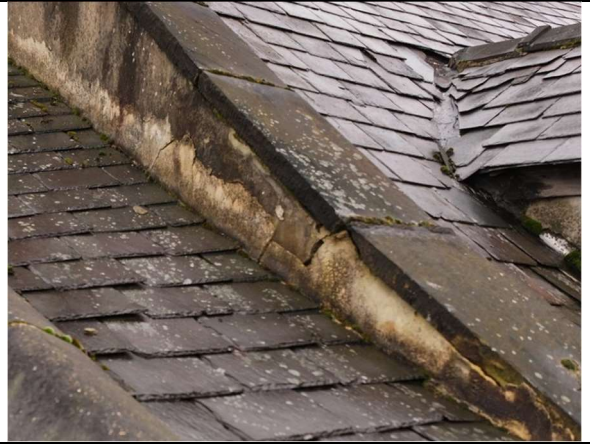
A 'hip' detail sits where the centre and right-hand pitches converge. This is not the best way to detail this abutment and will add additional weight to the roof structure. The pointing is cracking in areas and we recommend this be raked out and repointed this year.

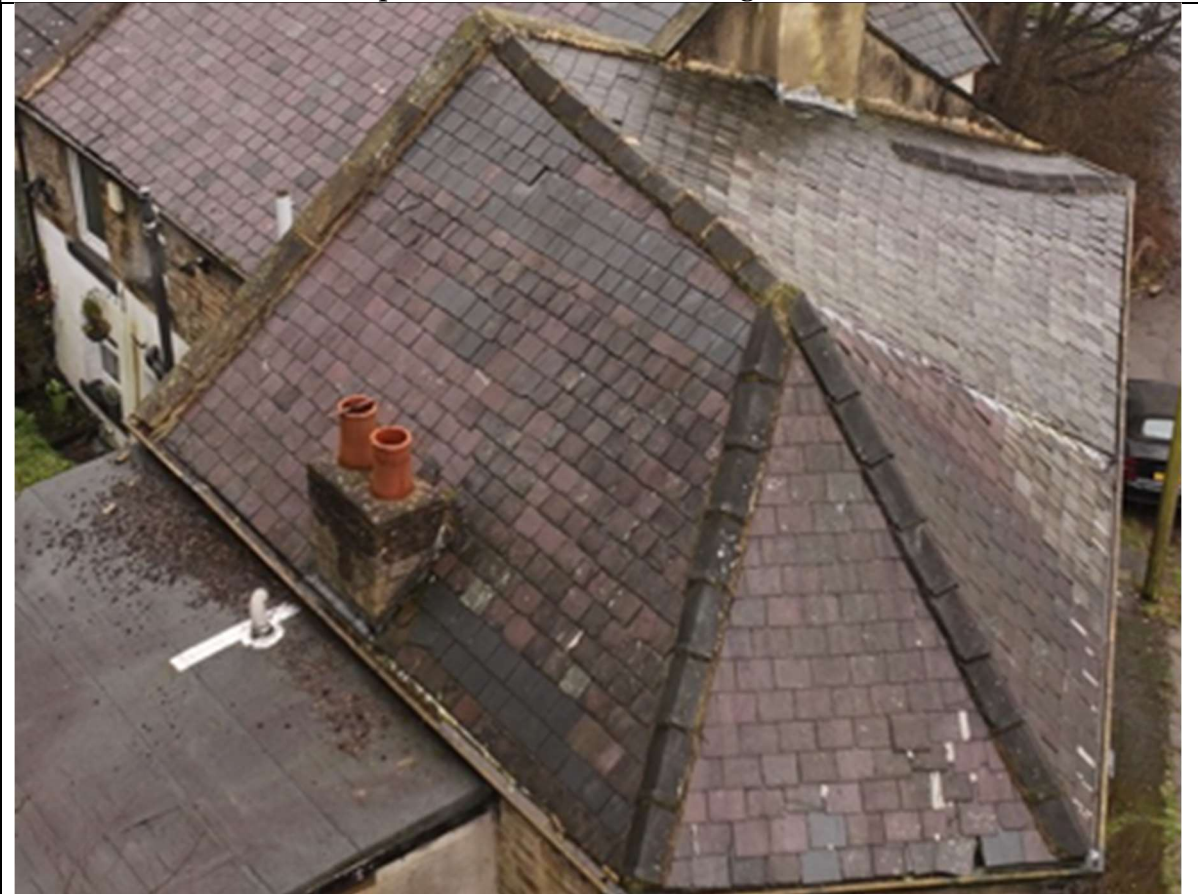
The parapet walls are outside the scope of this inspection; however, we noted they appeared to be in poor condition and will need repair work in the short term.

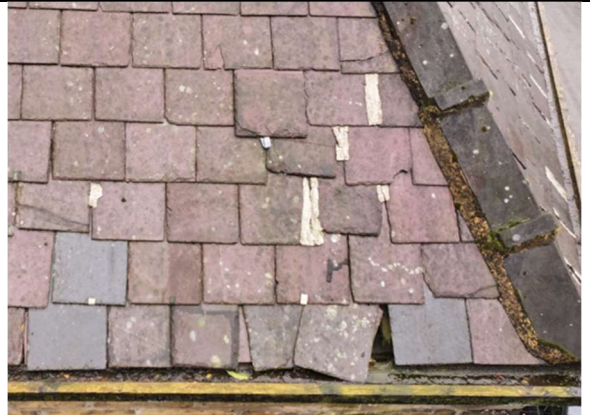
Side-on photo of the rear pitches – left and right-hand. The upper element of the rear pitch has been re-covered in non-matching slates. The pitch is in generally poor condition and in need of immediate repair and will need recovering in the not-too-distant future.

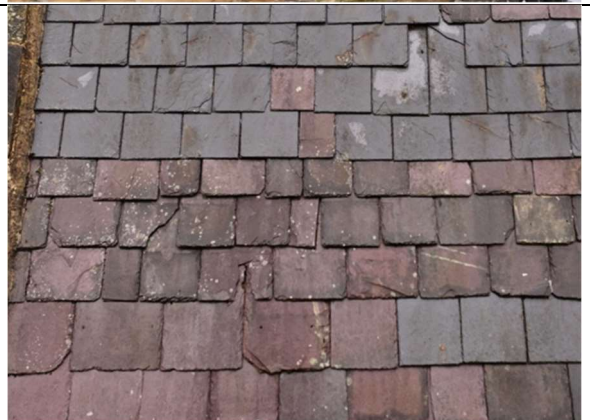
Side pitch – the area of slipping and damaged slates should be replaced in the next couple of months.

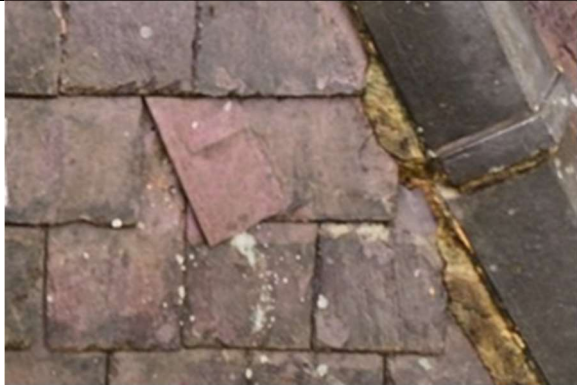
Missing and damaged slates should be replaced as soon as possible.

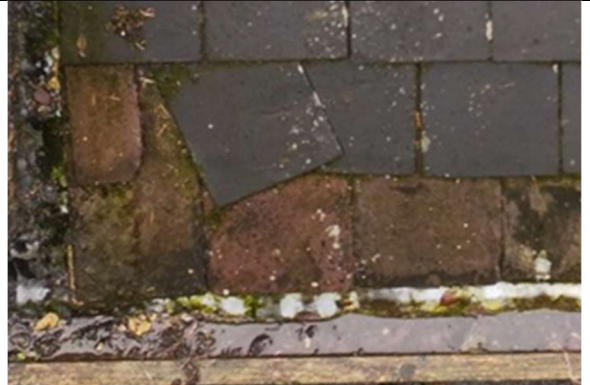
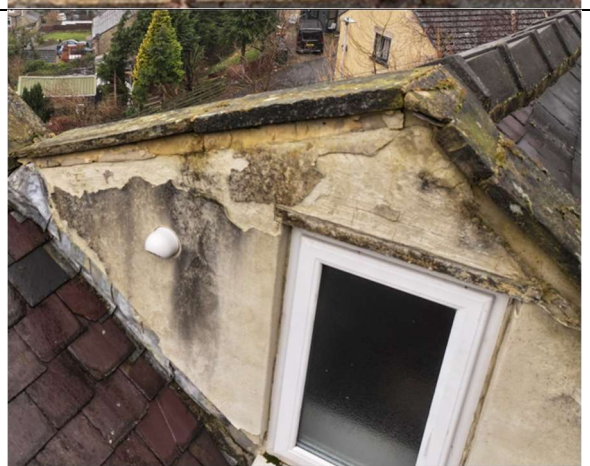
Slipping slates should be replaced as soon as possible.

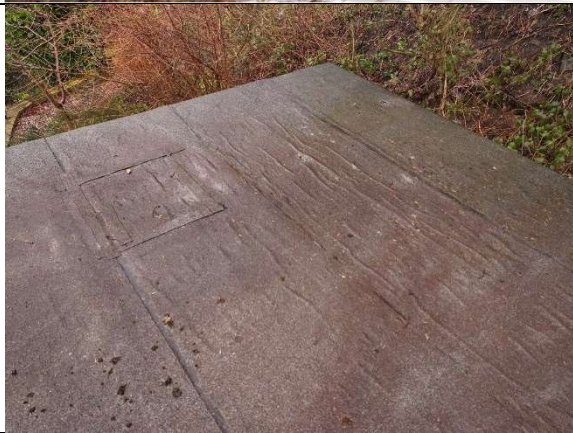
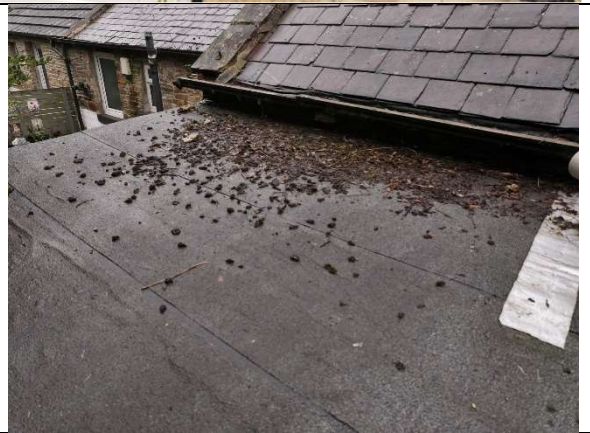
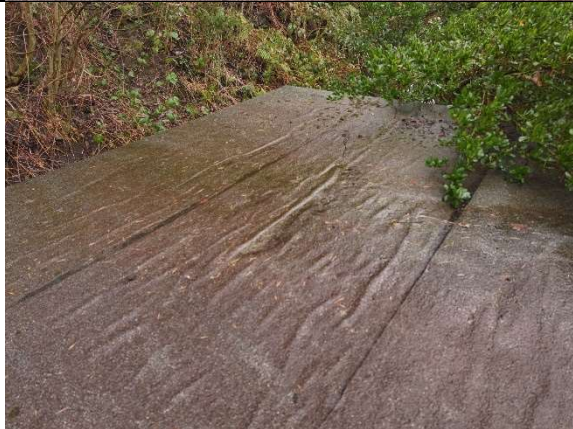
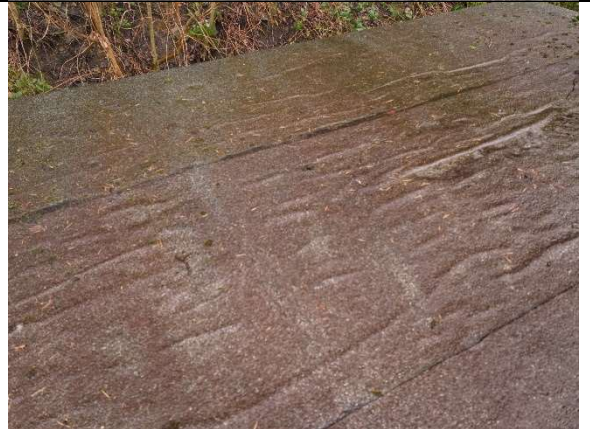
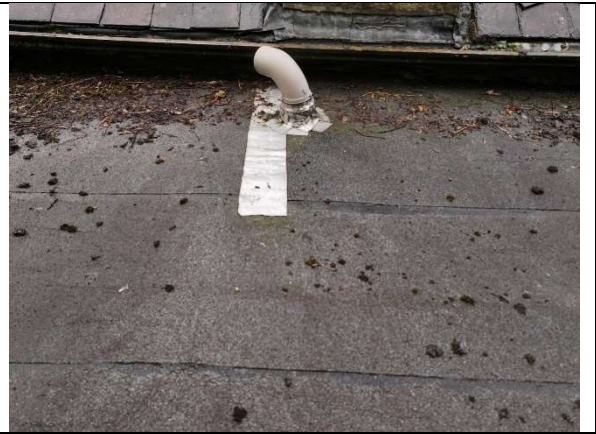
Overhead photo of the flat roof area. The mineral felt covering has had several repairs and is ruckling in all areas suggesting there is moisture trapped and it has de-bonded from the substrate. A plan should be made to replace this covering in the short term. When the covering is stripped, the deck should be inspected. If moisture has been getting in, it is likely that this will need repairs or replacement. We have included some example photos below.

The penetration through the covering has been incorrectly and poorly detailed. This needs to be appropriately designed when it comes to planning the re-covering of the roof.
