# Rotorgraph

## Roof Inspection Report

124 Livingstone Road

16<sup>th</sup> February 2025

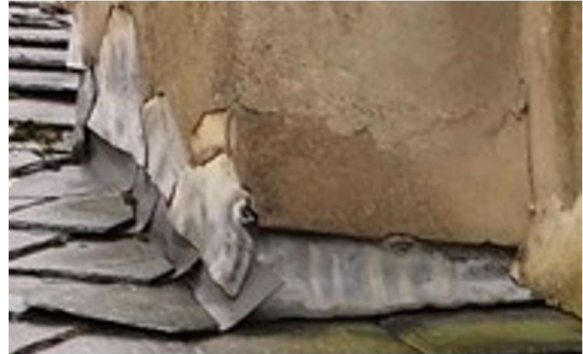
Rear Stack

Pots

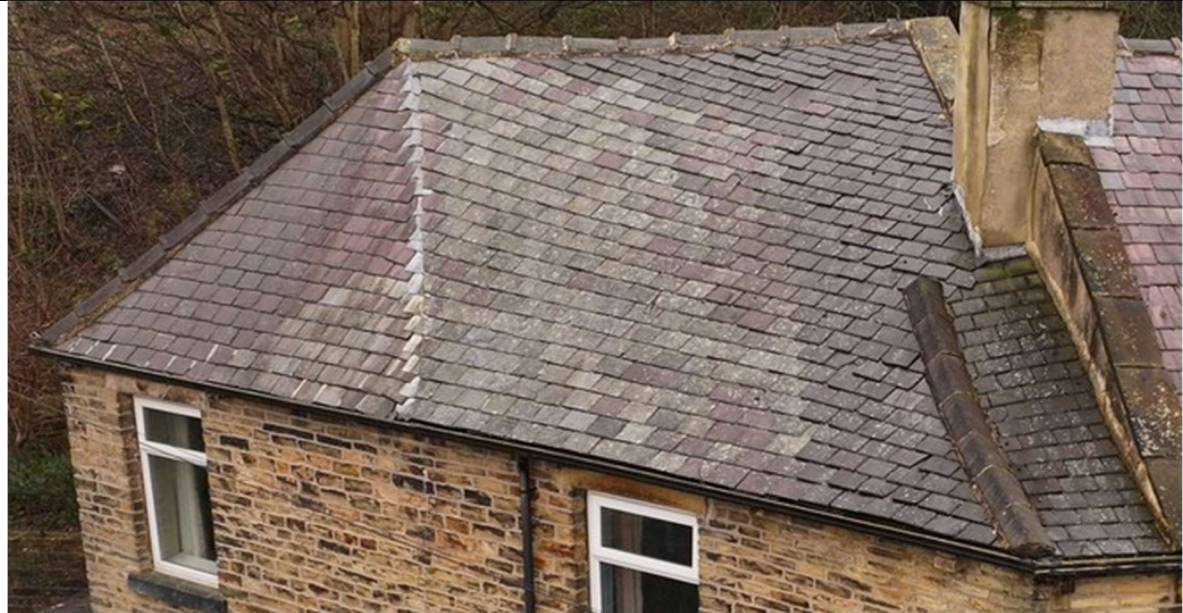
General comment – in several areas, the slates do not sit flat to the pitch which will likely accelerate fixing failure as a result of wind rattle.

We have included some example photos of this as opposed to every area where this is a problem.
